car stereo Service Bulletin No.85

Model: CDX-5/R7

Date: September 18, 1987

Subject: No Eject

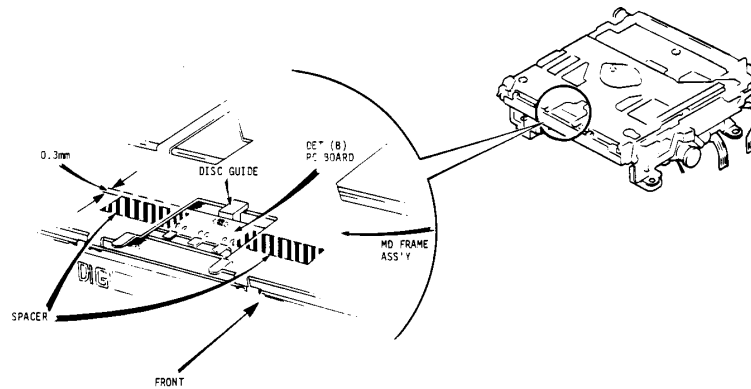
The compact disc is not ejected when the set is installed at a 20° angle. At this angle, the lid remains open so when the roller moves up the disc to eject it, the disc pivots, hits part A of the lid, getting stuck.

Insert two spacers (3-323-288-01) between the DET (B) PC board and the MD frame assembly.
