car stereo Service Bulletin No.89

Model: XR-550R

Subject: Unit Continuously Cycles
Direction

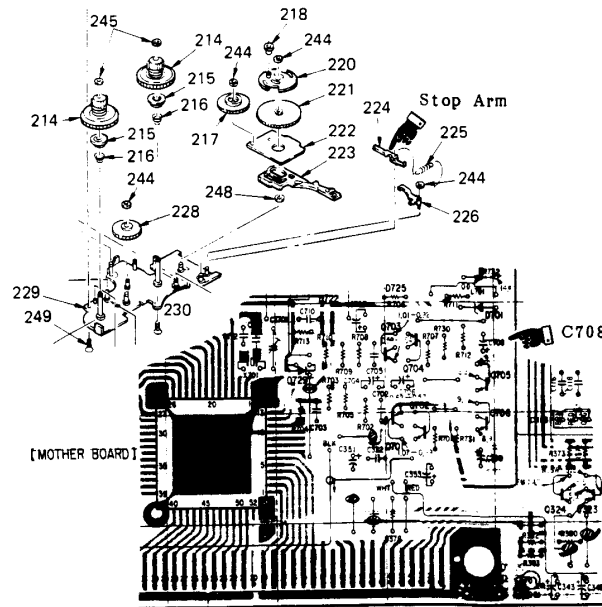
When a tape is inserted, the unit will continuously cycle directions. The head plate moves in and out but never locks.

C708 on the Main PCB obstructs the movement of the STOP ARM (Ref. No. 224). This bends the STOP ARM.

Bend the STOP ARM to restore original shape or replace STOP ARM. Reposition C708 so it does not obstruct the STOP ARM.
