car stereo Service Bulletin No. 92

Model: XR-50/70

Date: December 28, 1987

Subject: Tape Deck Mechanism Parts
Change - Reference No. 385,
387, 388

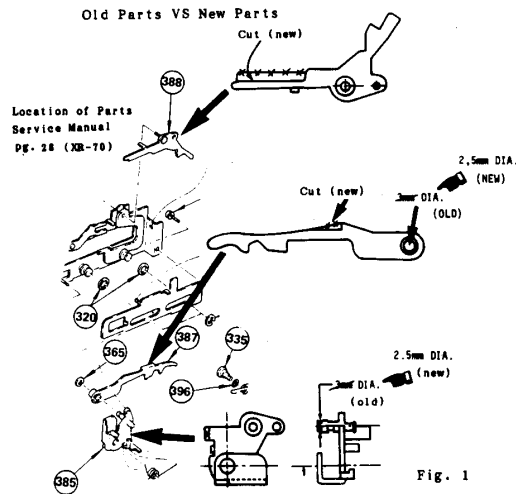
During the production of the XR-50/70 car stereo, a change was made in the tape deck mechanism. The parts which are affected are shown below. The specific portion of the part that was changed is also shown (Fig. 1).

The new parts and old parts are not compatible with one another. Only the new parts are available from Kansas City Parts. If any one of these three parts must be changed in a unit containing the old parts, all three parts must be changed. The part numbers for the three parts have not been changed from the originals.

Ref. No.	Description	Part Number
385	Link Ass'y, Function, Holder	X-3573-817-0
387	Lever Ass'y, Joint	X-3573-819-0
388	Plate Ass'y, Lock	X-3573-820-0
