**Car Stereo
Service Bulletin**

Model: XR-7100

No. 100

Subject: Interruption Of Audio When
Illumination Is Switched On/Off

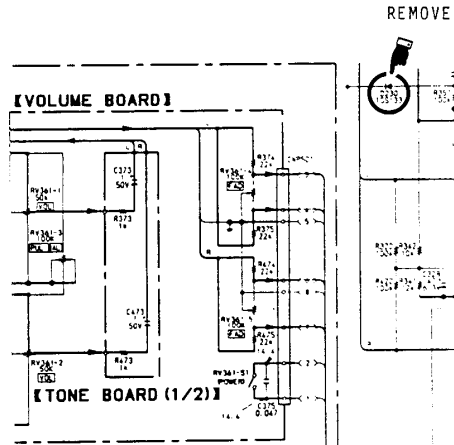
The audio output may be interrupted for an instant when the illumination is turned on or off. This is due to a muting circuit momentarily engaging.

Solution: Remove diode D230. This has already been changed in production. The diode needs to be removed for serial numbers 10001 - 18100.
