Car Stereo  
Service Bulletin

**Model:** XK-8D

**No.** 107

**Subject:** Direction May Change During Playback

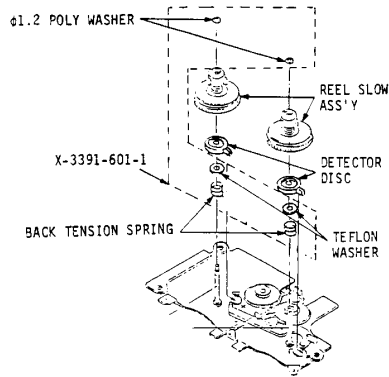
The back tension spring is weak, so the detector link lever is unstable. Another cause may be the back tension spring is hooked at the detector disc.

**Solution:** Replace the back tension spring and add a teflon washer between the back tension spring and detector disc as shown.

**Note:** When installing the detector disc, the protruded portion must be aligned as shown.
