**Car Stereo
Service Bulletin**

Model: CDX-A20/A20R

No. 114

Subject: Skipping On Scratched Discs

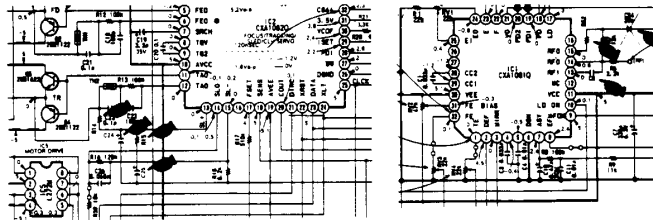
Symptom:
(62)

Skipping occurs during idling, or when driving on normal roads.

Solution: Please replace the following parts:

Ref. No.	Description		New Part Number
	Former	New	
R14	82k Ω	330k Ω	1-215-481-00
R15	15k Ω	68k Ω	1-249-439-11
R52	8.2k Ω	15k Ω	1-249-431-11
C8	0.0047 μ F	0.018 μ F	1-163-062-00
C24	3.3 μ F	0.056 μ F	1-136-162-00
C25	22 μ F	2.2 μ F	1-124-257-00
C54	20pF	Remove
