**Car Stereo
Service Bulletin**

Model: CDX-A20/A20R

No. 117

Subject: No Operation And Error Message
E-99 On Display

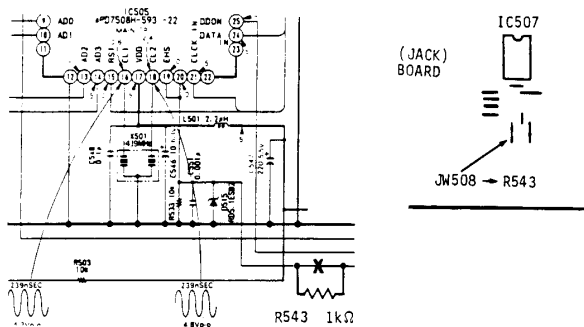
Motor noise affecting the EHS (elevator height sensor) may cause misoperations such as returning the disc to the wrong slot, or taking the disc from the wrong slot.

Solution 2-2

1. Change C551.
2. Replace JW508 with R543.

Description		Part Number
Former	New	
C551	100pF	1-163-077-00
JW508	Jumper	1-249-417-11
	R543	1k Ω
