**Car Stereo
Service Bulletin**

Model: RM-X2

No.120R1

Subject: Volume Changes Too Drastically

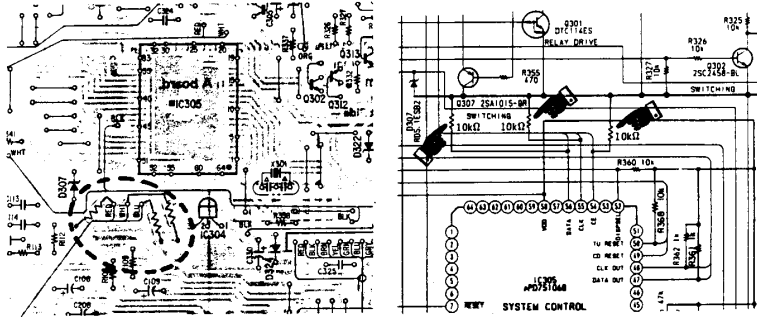
Symptom: This Service Bulletin Supersedes Service Bulletin No. 120 (52)
There is a large change in volume when the volume display switches from the third to the fourth step.

Solution: 1. Replace the microprocessor IC with a new one.

2. Add 10k resistors to the CE, CLOCK, and DATA lines after replacing IC-305. These are Pins 54, 55, and 56 respectively.

3. Short Pins 27 and 28 of IC305 together.
