Car Stereo
Service Bulletin

Model: CDX-A30

No. 130

Subject: Distorted Audio When Connected
To RM-X2

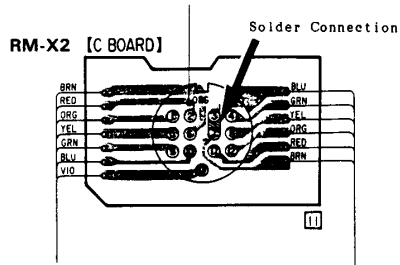
There is distorted audio when the CDX-A30 is connected to an RM-X2. This is caused by both units floating the ground connection at their end.

Jumper across Pins 3 and 7 on the input connector as shown:
