**Car Stereo
Service Bulletin**

Model: XR-7050

No. 131R2

Subject: Intermittent FM Reception

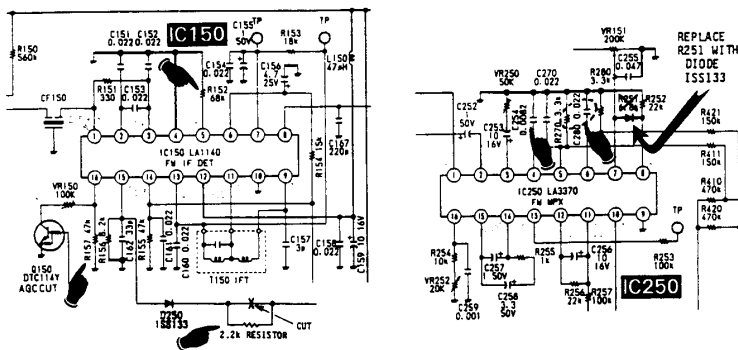
When receiving FM, the high-frequency range of the audio signal is cut off intermittently, especially when driving in a weak electric field. This is caused by misoperation of the high cut circuit.

Solution: Change the following parts on the main board:

Description				
Ref. No.	Former	New	Part Number	Remarks
R152	68k Ohm	33k Ohm	1-247-726-11	
R251	6.8k Ohm	1SS133	8-719-901-33	
C254	0.0082µF	0.01µF	1-161-051-00	
C270/280	0.022µF	0.027µF	1-161-056-00	
---	---	2.2k Ohm	1-247-717-11	Mount resistor in series with D250
R157	47k Ohm	68k Ohm	1-249-467-11
