Car Stereo Service Bulletin

Model: XM-801

No. 133

Subject: Thermal Protector Trip Point

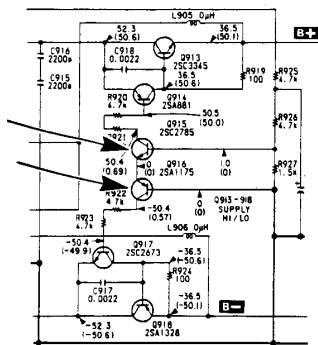
Amplifier
CSA-14

The thermal protector reacts prematurely during high-power playback (maximum power at no distortion).

Cause:
Q915 and Q916 are defective. In the stereo mode, the voltage applied to these transistors exceeds the rating voltage so the temperature of the power amplifier IC rapidly increases when the transistors prove defective.

Change Q915 and Q916.
