Car Stereo  
Service Bulletin

**Model:** XR-7150/7200

**No. 136**

**Subject:** Intermittently No Reverse

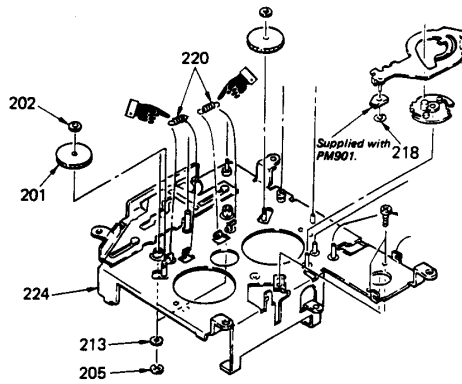
The tension of the play arm springs is too low.

**Solution:** Replace the two tension springs of the play arm as shown below:

Ref. No.	Description	Part Number	
		Former	New
220	Spring (play arm), Tension	3-344-218-01 Silver	3-344-218-02 Black
