**Car Stereo  
Service Bulletin**

**Model:** CDX-R77, CDX-R79

**No. 137R1**

**Subject:** Intermittent, No Play

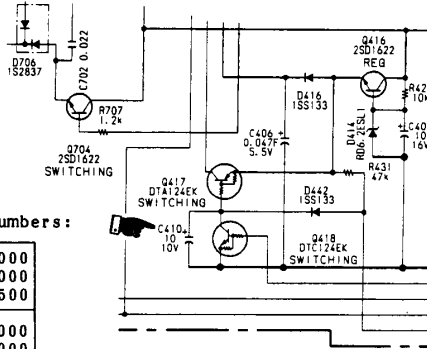
If the ignition is turned Off (ACC lead HIGH to LOW), while playing a CD, and then ignition is turned On, no functions will be accepted and there will be no display indication.

**Solution:** Please replace capacitor C410 with a new value as shown below:

Ref. No.	Former Part	New Part	
		Description	Part Number
C410	10 $\mu$ F/10V	22 $\mu$ F/16V	1-124-234-00
