Car Stereo
Service Bulletin

Model: CDX-R77, CDX-R79

No. 145

Subject: Volume Control Does Not Work

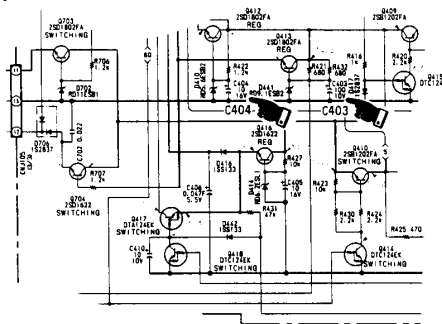
At power up, the rise time for the analog and digital power supplies do not match causing the electrical volume to lock up.

Solution: Replace the following chemical capacitors:

Ref. No.	Former Part	New Part	
		Description	Part Number
C403	100 μ F/10V	47 μ F/16V	1-124-589-11
C404	10 μ F/16V	22 μ F/16V	1-124-234-00
