**Car Stereo
Service Bulletin**

Model: XR-7180

No. 148R1

Subject: Preventing Damage To Output Devices During And
Subsequent To Servicing

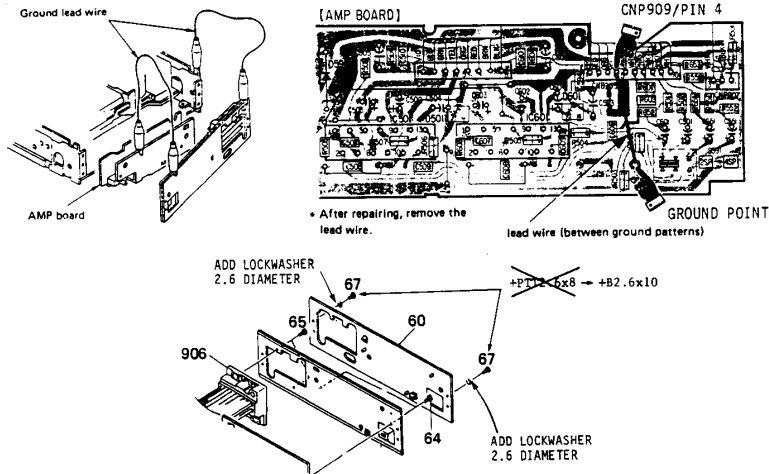
When the unit is being serviced, one or both output devices may be damaged if the following grounding procedure is not followed. The output devices may also fail at some time subsequent to servicing if the screws which secure the rear cover to the chassis become loose.

Prior to applying power to the unit, add a lead wire to the amp board and connect jumper leads between the rear cover, amp board, and chassis as shown below. When reassembling the unit, secure the rear cover to the chassis with new hardware as shown below:

REF. NO.	FORMER		NEW	
	DESCRIPTION	PART NUMBER	DESCRIPTION	PART NUMBER
67	SCREW +PTT 2.6X8	7-685-793-01	SCREW +B 2.6 X 10.0	7-621-773-67
---	---	---	SPRING, WASHER 2.6 DIA	7-623-207-22
