Car Stereo
Service Bulletin

Model: CDX-R77, CDX-R79

No. 149 R1

Subject: Malfunction of Power Antenna

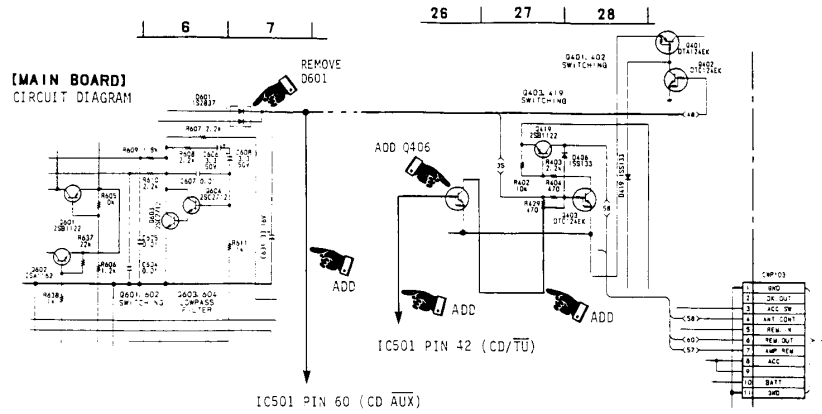
The power antenna rises when ACC line goes from LOW to HIGH or when unit is switched to AUX mode.

Cause: The microprocessor does not output the port data of the PLL IC, which controls the voltage to the tuner.

1. Remove D601.
2. Add transistor DTC124EK (P/N 8-729-901-00) as Q406.
3. Add three wires:

Q406 base	IC501 #42 pin (CD/TU)
D601 cathode	IC501 #60 pin (CD/AUX)
Q406 collector	Q403 base

For details, refer to the schematic and mounting diagrams on the next page.
