Car Stereo
Service Bulletin

Model: CDX-A20

No.152R1

Subject: Improvement of Signal to
Noise Ratio

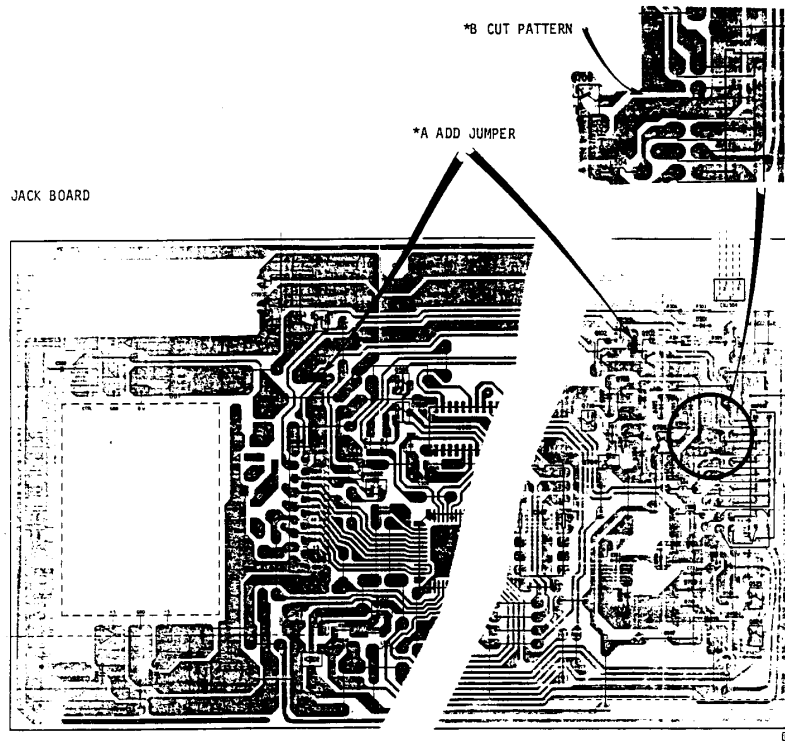
FIG. 1

If the customer complains of hearing servo noise during quiet passages or between tracks, replace the "RF" Board with an improved board as shown below.

1. Replace "RF" Board.
2. Re-adjust Focus and Tracking Bias.
3. Modify the Jack Board (Diagram 1).
4. Add Jumper between "RF" Board and Antenna Shield Board.
