# Car Stereo Service Bulletin

**Model:** CDX-R77/79

**No.** 157 R1

**Subject:** If Customer Complains Of Distortion **Date:** April 10, 1990

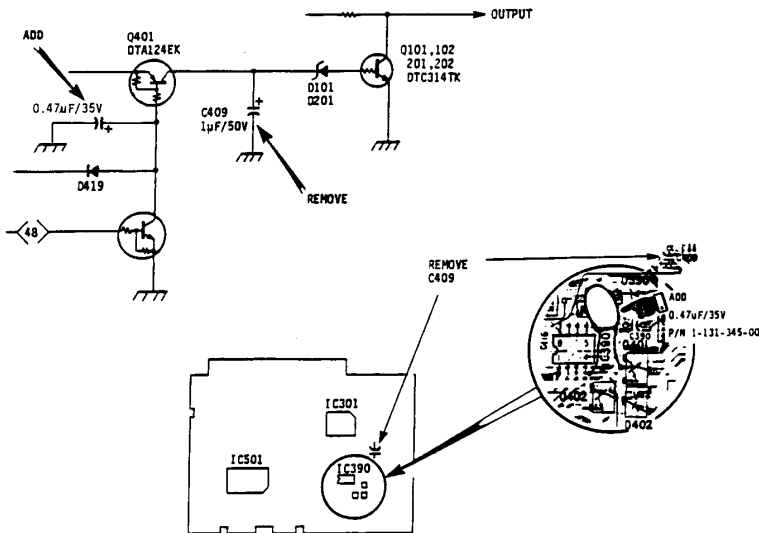
**MAIN BOARD CIRCUIT & PATTERN**

When measuring distortion, the reading will initially be very high as player begins playing a track.

**Solution:** Remove Capacitor C409, and install a .47 $\mu$ F/35V Tantalum Capacitor (Part Number 1-131-345-00) from Pin 4 of IC390 to the base of Q401. Please note proper polarity.
