**Car Stereo
Service Bulletin**

Model: XR-66/740/A740/780/787R

No. 164

Subject: Intermittent No Eject

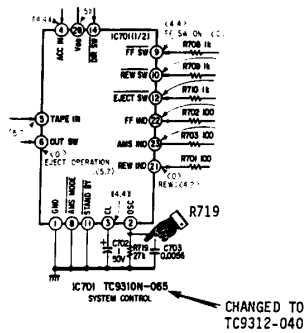
Irregular eject in play mode. IC701 has been changed from TC9310N-065 to TC9312-040. A further modification is necessary as instructed below when using TC9312-040.

- Solution:**
1. Change the value of R719 from 27k Ohm to 47k Ohm.
 2. Remove the timing board for the units in which the timing board is installed. The timing board is attached to the outside of the motor.
