**Car Stereo
Service Bulletin**

Model: CDX-A30RF

No. 168

Subject: Spikes On ACC Line Cause
Misoperation

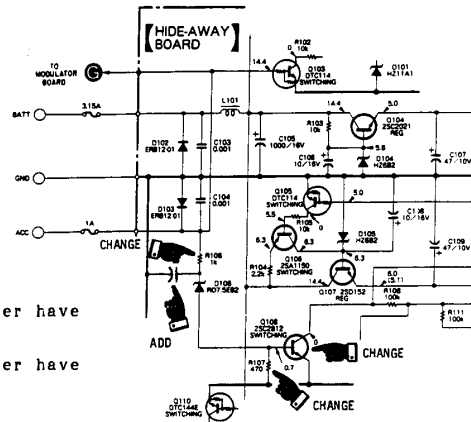
Unit mutes when lights, wipers, or fan are turned on.

Cause: The ACC line varies due to spikes caused by switching.

Solution: Change the following parts:

| | Description | | | |
|---|---|---|---|---|
| Change | Q108 | 2SC2812 | DTC144EK | 8-729-901-01 |
| | R106 | 1k Ohm | 2.2k Ohm | 1-216-057-00 |
| | R107 | 470 Ohm | 22k Ohm | 1-216-081-00 |
| Add | --- | --- | 10u/16V | 1-126-157-11 |
