Car Stereo Service Bulletin

Model: XR-7050

No.171

Subject: Handle Breaks From Hinge

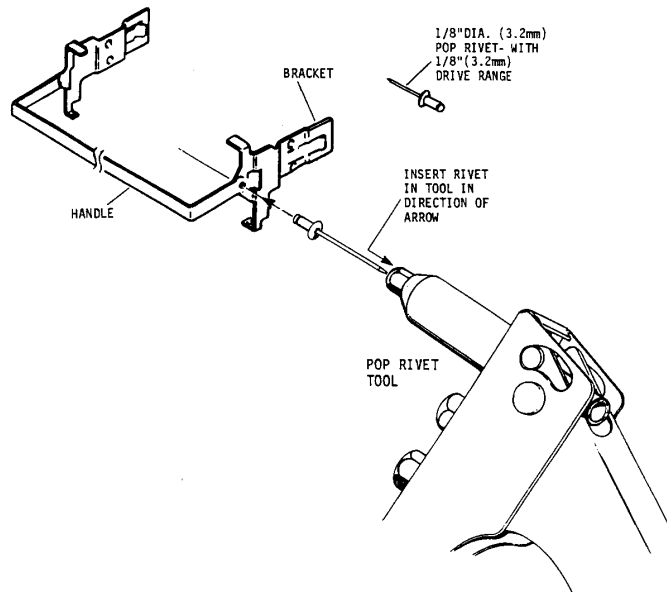
An alternative to replacing the Hinge Assembly when the handle breaks away from the bracket, is to repair it using pop rivets.

Solution: Obtain two pop rivets of size 1/8" diameter and 1/8" drive range. Using a pop rivet tool, insert the pop rivet through the handle and then into the bracket, as shown.

Verify that the handle swings freely.
