Car Stereo  
Service Bulletin

**Model:** CDX-44/6020/7540/7580/R77/R79

**No.** 174

**Subject:** Some Functions Do Not Operate

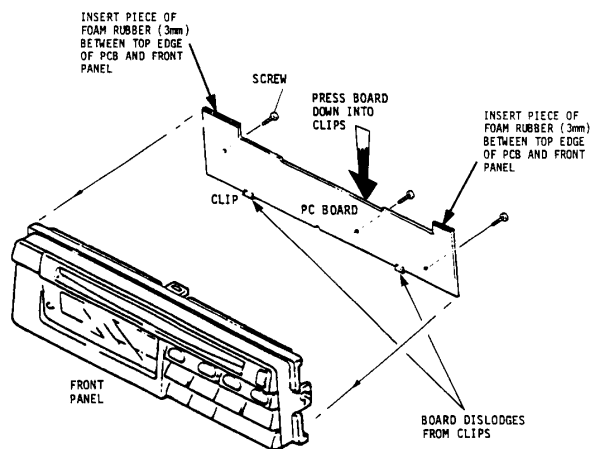
The Display PCB becomes unseated from the plastic clips that hold the lower edge of the board causing no operation of several buttons on the front panel.

**Solution:** If this symptom occurs, insert a 3mm piece of rubber foam, Part Number 9-911-815-01, between the Front Panel and the top edge of the PCB, as shown below.

When installing the unit, press the PCB following the arrow and tighten screws.
