**Car Stereo  
Service Bulletin**

**Model:** RM-X2001

**No. 180**

**Subject:** ACC SW Turns Off, But RM-X2001  
Stays On

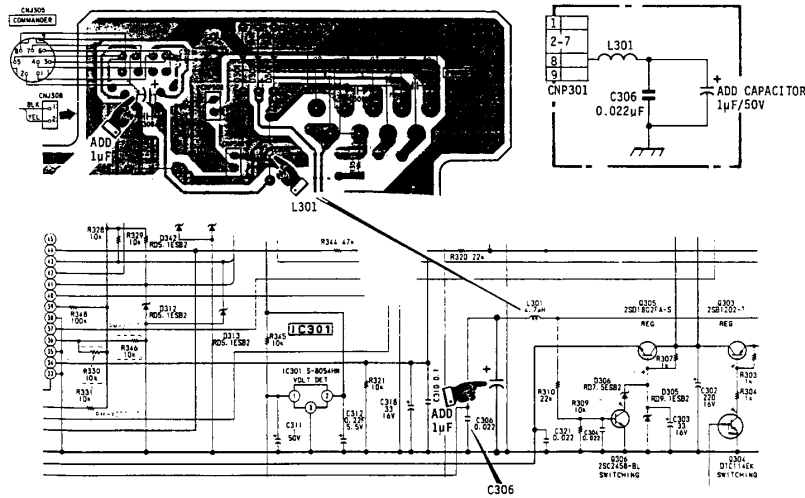
If when the ACC SW is turned off the back light on the RM-X2001 stays on, the problem is due to the spike generated by L301.

**Solution:** Add a 1 $\mu$ F capacitor across C306.

**Note:** If the unit is already installed, add a 4.7 $\mu$ F/63V (Part Number 1-123-369-00) from ILL terminal to chassis GND.
