**Car Stereo
Service Bulletin**

Model: CDX-A100

No. 181

Subject: No Operation and No Eject
("E99" Is Indicated)

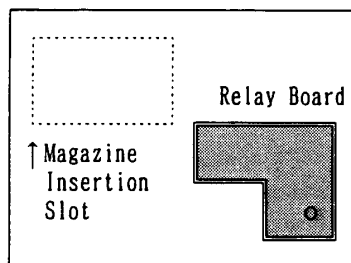
Fig. 1.

The unit neither operates nor ejects ("E99" is indicated). This happens when the Relay Board touches the MD Chassis and the M1 Motor will not turn.

1. Remove Rear Case.
2. Remove Case Assembly.
3. Remove Upper Case Assembly.
4. Pull out all the connectors of the Relay Board, and unscrew and take out the Relay Board (Fig. 1).
