Car Stereo
Service Bulletin

Model: CDX-7560/7580

No. 186

Subject: Power Not On When Inserting Unit, No Sound (Power) While Driving
Date: November 30, 1990

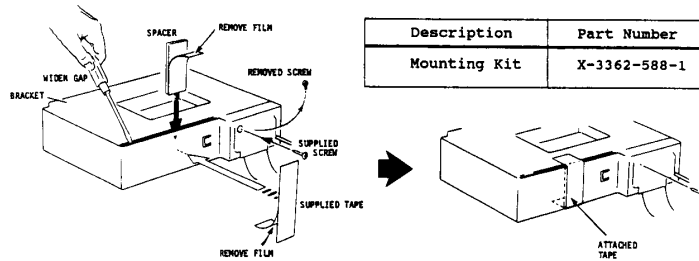
Symptom: The unit will not power On after being inserted, or there is no sound (power) while driving.
(11)

Cause: There is incomplete contact of the unit and the connector on the bracket assembly. This is due to the rear of the bracket pushing against the car body. Therefore, the unit is not inserted completely and SW901 (handle) is set in the Off mode.

Solution: If this symptom occurs, install a spacer (P/N X-3362-588-1) by performing the following procedure:

1. Remove the amplifier from the bracket.
2. Use a screwdriver to widen the gap at the rear of the bracket.
3. At the same time, peel off the film from the supplied spacer and insert and attach it to the bracket.
4. Attach the supplied tape as illustrated.
5. Remove the screw and replace it with the supplied screw as illustrated.
6. Attach the amplifier back to the bracket.
