**Car Stereo
Service Bulletin**

Model: XE-90MKII

No. 189

Subject: IC101/PC Board Compatibility
Problem

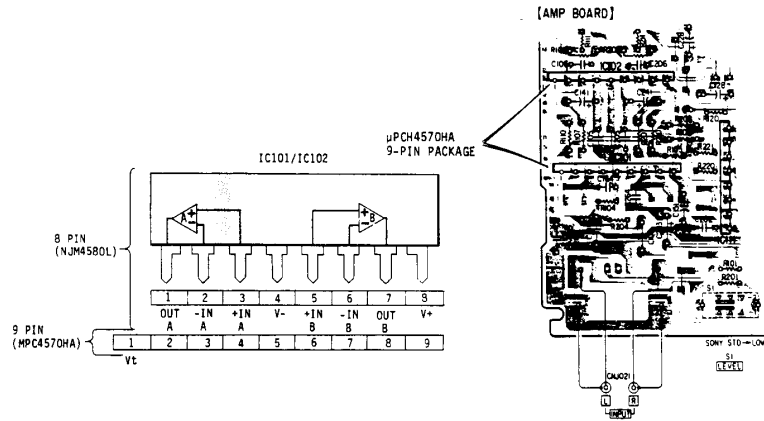
Symptom:
(53)

Audio distorted.

Replace IC101 and/or IC102 with Part Number 8-759-710-73 (NJM4580L). This is an 8-pin in-line package which will fit the PC Board without modification.

If this part is not available, then order Part Number 8-759-112-93 (uPC4570HA). This is a 9-pin in-line package which may be used if Pin 1 is removed and the IC is inserted so that Pin 2 is located in the PC Board Pin 1 position.
