Car Stereo
Service Bulletin

Model: CDX-7520/-7560

No.195

Subject: High Level Access Noise From
Speaker During AMS Mode of CD

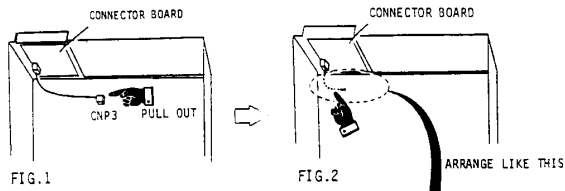
Audible access noise is present during AMS mode of CD. The lead wire of Audio GND line picks up the noise therefore varying GND potential.

1. Remove the mechanism
2. Disconnect connector CNP3 on side B of the Main Board. (see Fig. 1)
3. Pre-route the lead wire to determine proper length as shown in Fig. 2 and Fig. 3.
4. Cut the lead wire to the length determined in step 3 and prepare as shown below:
