**Car Stereo
Service Bulletin**

Model: ES-R6/-R400, XR-170/-4057/-5500

No. 198

Subject: Tuner inoperative after cassette is ejected.

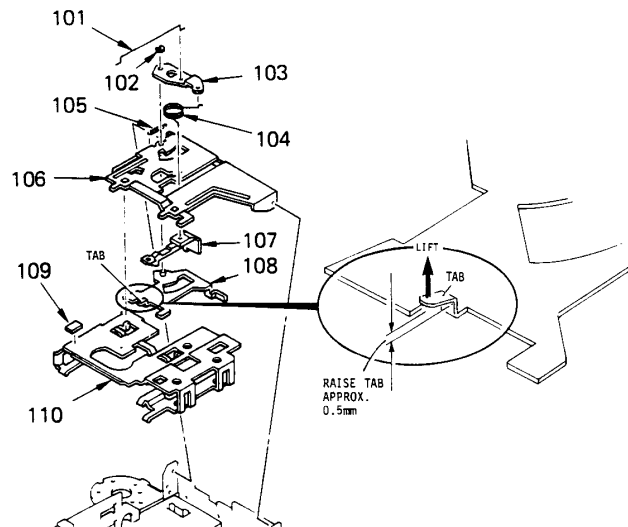
The tuner may not operate after a cassette has been ejected. This occurs when the small tab on the eject cam lock assy. (ref. 108) is misadjusted, allowing the cassette holder (ref. 110) to drop back down into the cassette loaded position.

Solution: Re-form the tab upwards approx. 0.5 mm, allowing it to engage the cassette hanger (ref. 106) properly, thereby preventing the cassette holder from dropping down.
