**Car Stereo
Service Bulletin**

Model: EXR-18; XR-3200

No. 355R1

Subject: No Power

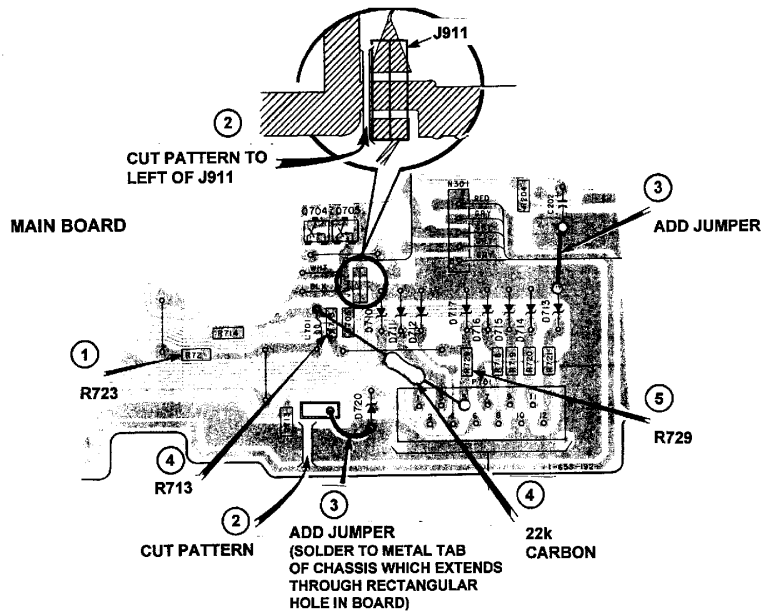
The unit appears to have no power (no functions/no illumination) although the fuse is good and the power lead connections are secure. If this symptom occurs it may be caused by the temperature and humidity conditions causing condensation to form on the CPU, preventing the ACCESSORY input pin 52 from properly interpreting the key-on condition of the accessory lead. It may also be caused by static discharge when touching or connecting the removable faceplate. When the unit is removed from the vehicle for service, it works properly on the bench.

- 1- Change the value of R723 on the Main board from 100K to 33K.
- 2- Cut the printed wiring pattern in 2 places as shown.
- 3- Add jumper wires in 3 places as shown.
- 4- Remove chip resistor R713 and replace it with a 22K carbon resistor as shown. Add insulation to the exposed leads of the resistor to prevent shorting to other components or the printed wiring.
- 5- Change the value of R729 from 33 ohm to 1K.
