Car Stereo Service Sbletin

Model: CDX-45/45RF/51/65/65RF/
71; EXCD-1RF

No. 358R2

Subject: Skipping When Outer Tracks Are Played.

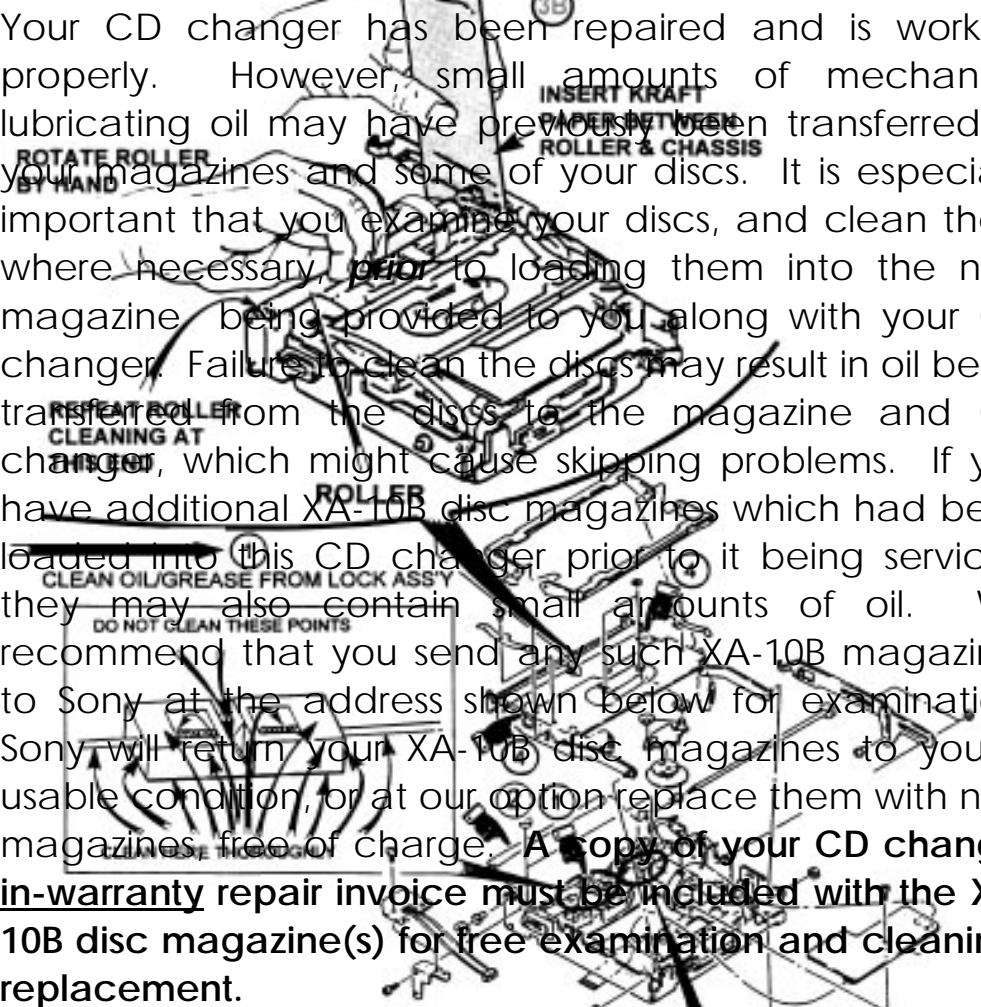
The audio skips when the outer tracks of the disc are being played. This symptom may be caused by grease and/or oil being deposited on the disc surface from the CD mechanism.

1- Thoroughly clean the grease and/or oil from the lock assy. **exactly as shown in the drawing.** First, remove any excess grease or oil by wiping the lock assy. with a dry cotton swab. Then, perform a final cleaning by wiping with a cotton swab moistened with alcohol.

2- Clean the rubber roller thoroughly with a cotton swab moistened with alcohol.

3- Move one side of the white plastic roller away from the metal plate, then thoroughly clean the roller (including the outer edge of the roller) with a cotton swab. Next, slip a piece of kraft paper (the paper that grocery bags are made of) between the ends of the roller and the chassis and rotating the roller by hand. Perform a final cleaning by wiping the roller with a cotton swab moistened with alcohol. Repeat this procedure for the opposite side of the roller.

4- Clean the white portions of the ARM(R) ASSY.

5- Remove the washer from the WORM WHEEL (C), then add a COVER (GEAR) and secure it with a +P 2x4 screw. Then reinstall the washer.
