Car Stereo Service Bulletin

Model: XR-1400

No. 361

Subject: Tape Audio Level Lower Than Tuner Audio Level.

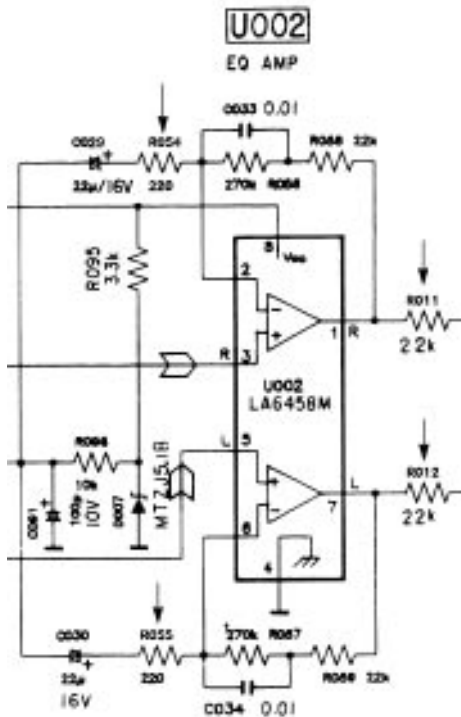
(52) The tape audio level may be lower than the tuner audio level.

If the customer complains about this problem, implement the component changes shown below.

REF	FORMER		NEW	
	DESCRIPTION	PART NUMBER	DESCRIPTION	PART NUMBER
R54 R55	RESISTOR, 220 OHM	1-247-815-11	RESISTOR, 100 OHM	1-247-807-11
R11 R12	RESISTOR, 22 K	1-247-863-11	RESISTOR, 2.2 K	1-247-839-11
