Car Stereo Service Bulletin

Model: EXR-21; XR-6450/C210/C410/C620

No. 364

Subject: Tape Does Not Eject.

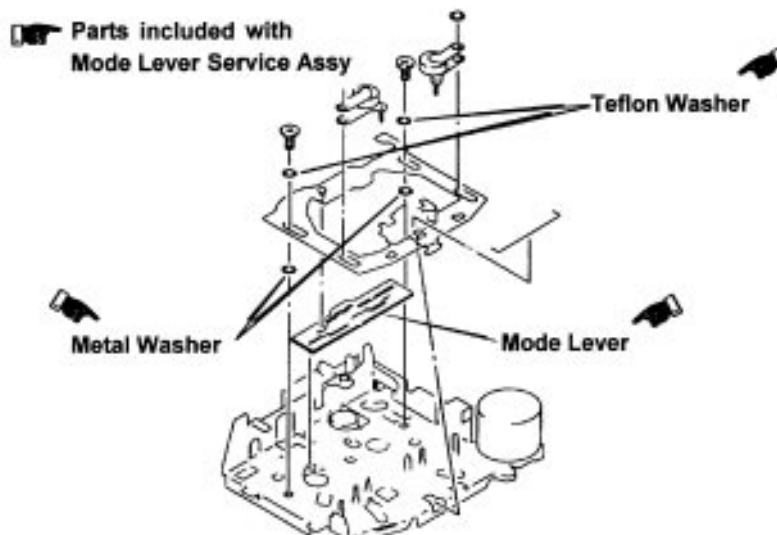
The unit will not eject the tape. Examination of the mechanism shows that one or more of the gears on the reel bracket assembly (ref. 128) are damaged.

Replace the reel bracket assembly. Prevent recurring damage to the reel bracket assembly by installing a mode lever service assembly kit as shown below.

REF	DESCRIPTION	PART NUMBER
128	BRACKET ASSY, REEL	X-3368-842-1
-	MODE LEVER SERVICE ASSY	X-3370-516-1
