## Car Stereo Service Bulletin

CSA-14

Model: CDX-71/71RF 365 No.

Subject: Controller Displays "ERROR"; Discs Load But Don't **Date:** May 2, 1995

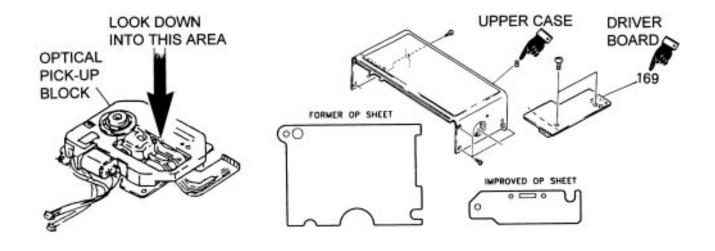
The display on the controller shows "ERROR" when the end of the current disc is reached. The mechanism loads the next disc, but will not play it. It then loads the next disc, but will not play it either. This problem may be caused by the optical pickup getting caught on the OP sheet as it tries to return to the innermost position, which prevents it from reaching the T.O.C. area of the disc.

Change the OP sheet (REF. 261) for an improved one which is smaller in size. Some units already have the improved OP sheet installed. The type of sheet in a particular unit can be identified as follows:

- 1- Remove the Upper Case, Ref. 8, and the Driver Board, Ref. 169.
- 2- Look down into the optical pickup block. If a black sheet is seen in the vicinity of the flex cable, replace the OP sheet with the improved one. If you can see the metal plate below the flex cable it is not necessary to change the OP sheet.
