Car Stereo Service Bulletin

Model: MDX-40/400

No. **376**

Subject: Skipping.

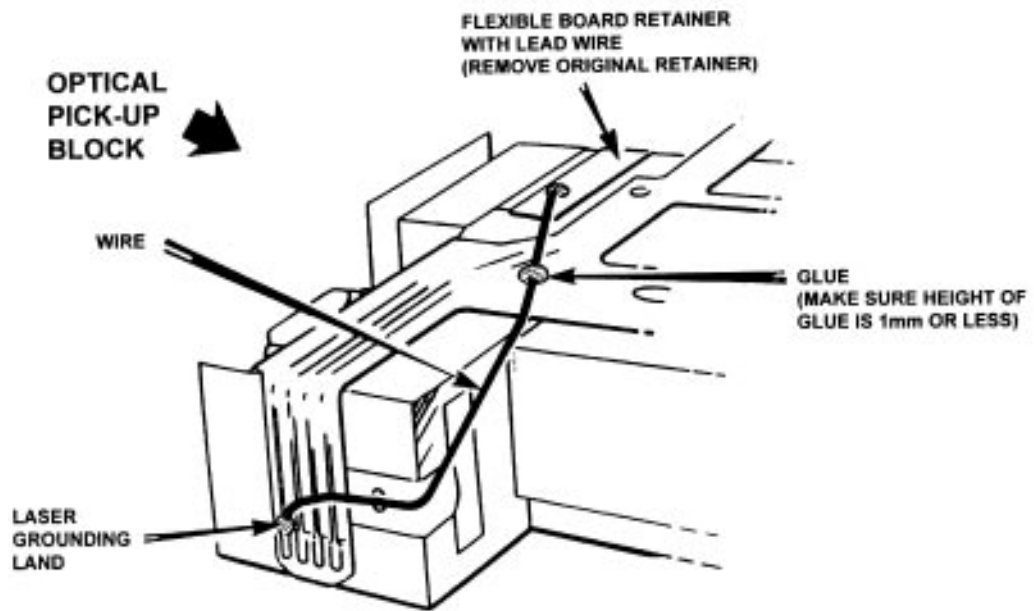
The unit skips while playing recordable or pre-recorded discs

- 1- Remove and discard the retainer which secures the flex cable to the optical pickup block.
- 2- Clean the area from which the retainer was removed with alcohol.
- 3- Install the new retainer which includes a lead wire.
- 4- Secure the lead wire with a small amount of glue as shown. **Be sure to keep the height of the glue droplet to 1 mm or less.**
- 5- Dress the lead wire snugly along the top of the optical pickup block and down the side as shown.
- 6- Solder the lead wire to the laser ground trace on the flex cable as shown.
