Car Stereo Service Bulletin

Model: XDP-U50D

No. 377

Subject: No Audio Or Distorted Audio When Connected To CDX-91 or MDX-40.

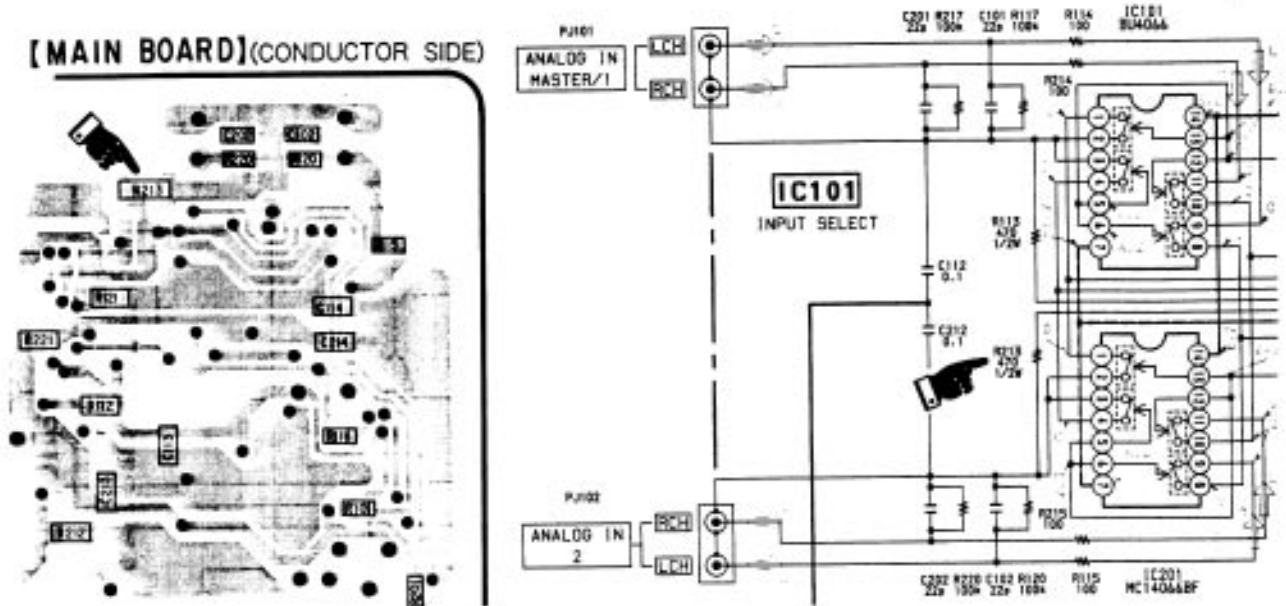
When the CDX-91 or MDX-40 is connected to the XDP-U50D "ANALOG IN 2" the audio might not be heard, or might sound distorted.

If the customer complains of this problem, replace R213 on the XDP-U50D Main board with a jumper wire as shown below.

REF	FORMER		NEW	
	DESCRIPTION	PART NUMBER	DESCRIPTION	PART NUMBER
R213	RESISTOR, MTL GLAZE, 470 OHM	1-202-999-11	JUMPER WIRE	-
