Car Stereo Service Bulletin

Model: XM-4525

No. 378

Subject: Power Supply Noise Heard Through Speakers.

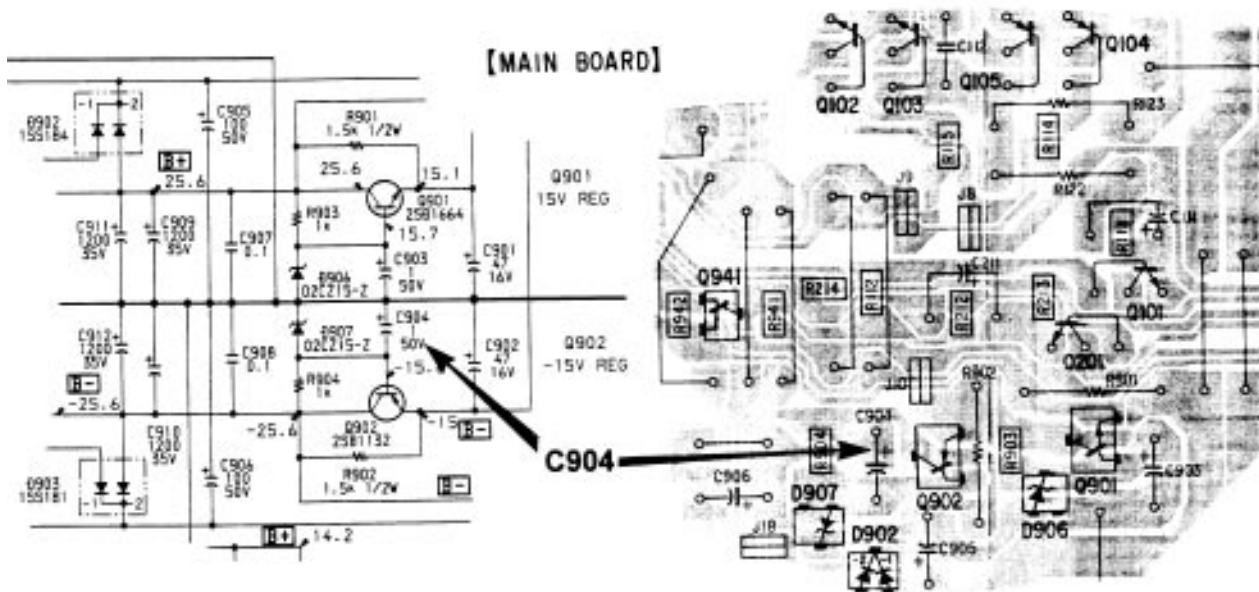
Noise generated by the power supply may be heard through the speakers. This problem may be caused by C904 being defective.

If the customer complains of this problem check C904 on the Main board and replace it if it is found to be defective. **Note that the polarity indicator silkscreened on the board is incorrect. The capacitor must be installed with polarity opposite that which is silkscreened on the board.**
