# Car Stereo Service Bulletin

No. 382

Subject: Preventing Recurring Damage To Amp IC And  
Power Supply IC.

Date: November 10, 1995

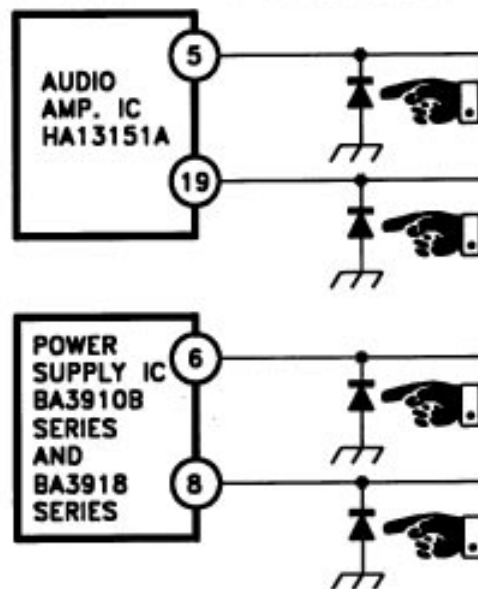
The HA13151A audio amp IC or the BA3910B/BA3918 series of power supply IC may sometimes be damaged by incorrect wiring connections or by counter-electromotive force generated by the vehicle's power antenna relay. The symptoms vary dependant upon which section of the IC fails.

If either of the above IC types is found to be damaged replace it, and prevent recurring damage by adding 2 diodes to the IC as shown below. In those models which use both types of ICs, add the diodes to both ICs even if only one is damaged.

REF	DESCRIPTION	PART NUMBER
-	DIODE, 11ES2	8-719-200-82
