# Car Stereo Service Bulletin

**Model:** XR-C210, XR-C410

**No.** 383

**Subject:** Intermittent Audio Muting

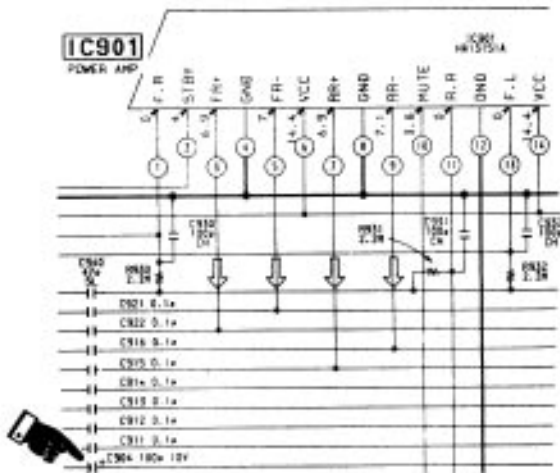
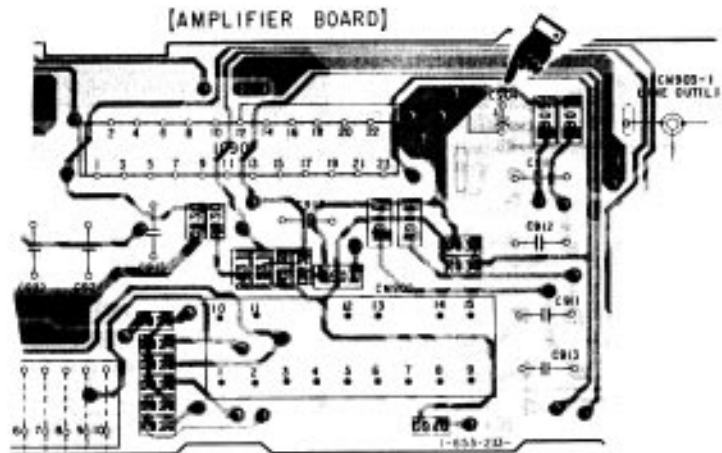
The audio may intermittently mute at high volume levels.

If the customer complains of this problem, change the value of C904 on the AMPLIFIER board as shown below.

REF	FORMER		NEW	
	DESCRIPTION	PART NUMBER	DESCRIPTION	PART NUMBER
C904	CAPACITOR, ELECT., 100UF, 10V	1-124-584-00	CAPACITOR, ELECT., 10UF, 16V	1-126-157-11
