# Car Stereo Service Bulletin

**Model:** CDX-91

**No. 390**

**Subject:** No Audio With MDX-U1 Or XDP-U50D.

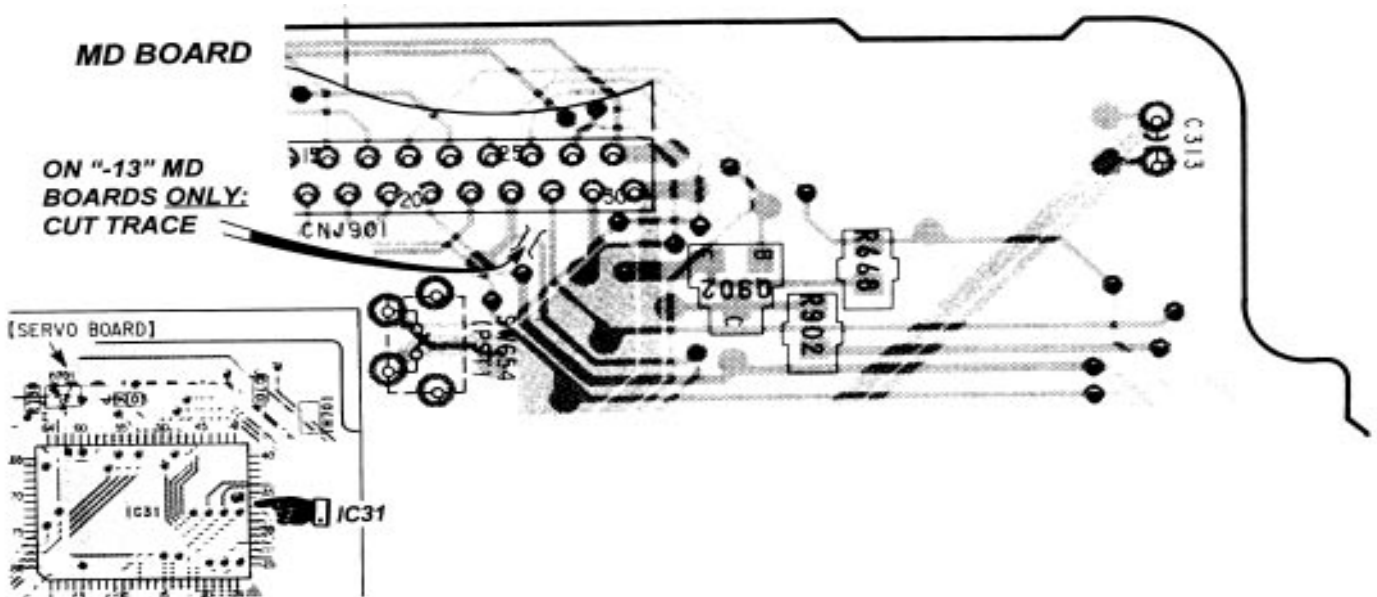
There is no audio when the CDX-91 is connected to the MDX-U1 or XDP-U50D via the analog connection (the audio is normal when the digital connection is used).

This problem may occur if IC31 on the CDX-91 **SERVO** board is the newest type (CXP84332-014Q). If the above mentioned symptom occurs, and if IC31 is the newest type, replace it with the former type (CXP84332-008Q). **Also**, if the suffix of the silkscreened part number on the **MD** board is "-13" a trace on the **MD** board must be cut as shown in the illustration. **Finally**, if the XDP-U50D is being used, make sure that the procedure described in Car Stereo Service Bulletin # 377 has also been performed.
