Car Stereo Service Bulletin

CSA-14

No. 394

Subject: Skipping Due To Vibrations And Shock.

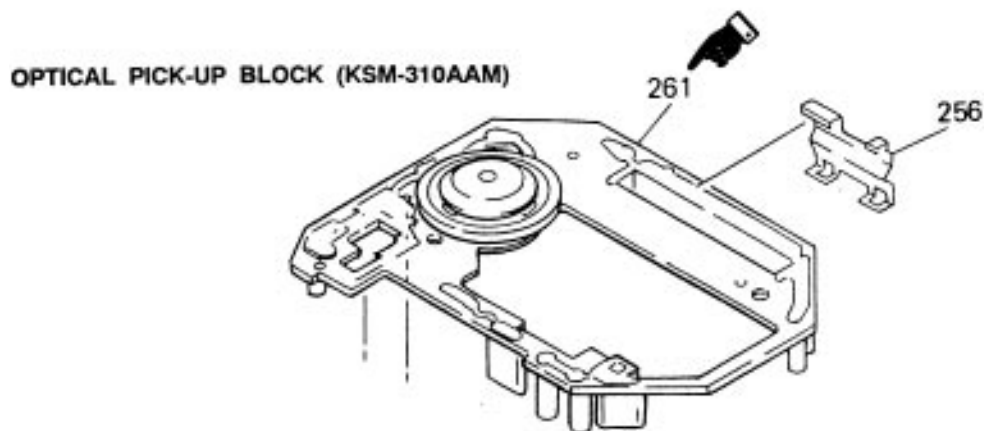
The unit may be unusually prone to mechanical shock and vibration.

If the customer complains of skipping due to mechanical shock or vibrations, replace the OMD chassis assembly with an improved type.

REF	FORMER		NEW	
	DESCRIPTION	PART NUMBER	DESCRIPTION	PART NUMBER
261	OMD CHASSIS ASSY	X-2625-270-1	CHASSIS ASSY (RP), ODM	X-2625-855-1
