# Car Stereo Service Bulletin

**Model:** MDX-100

**No.** 395

**Subject:** Skipping And/Or Drop-outs.

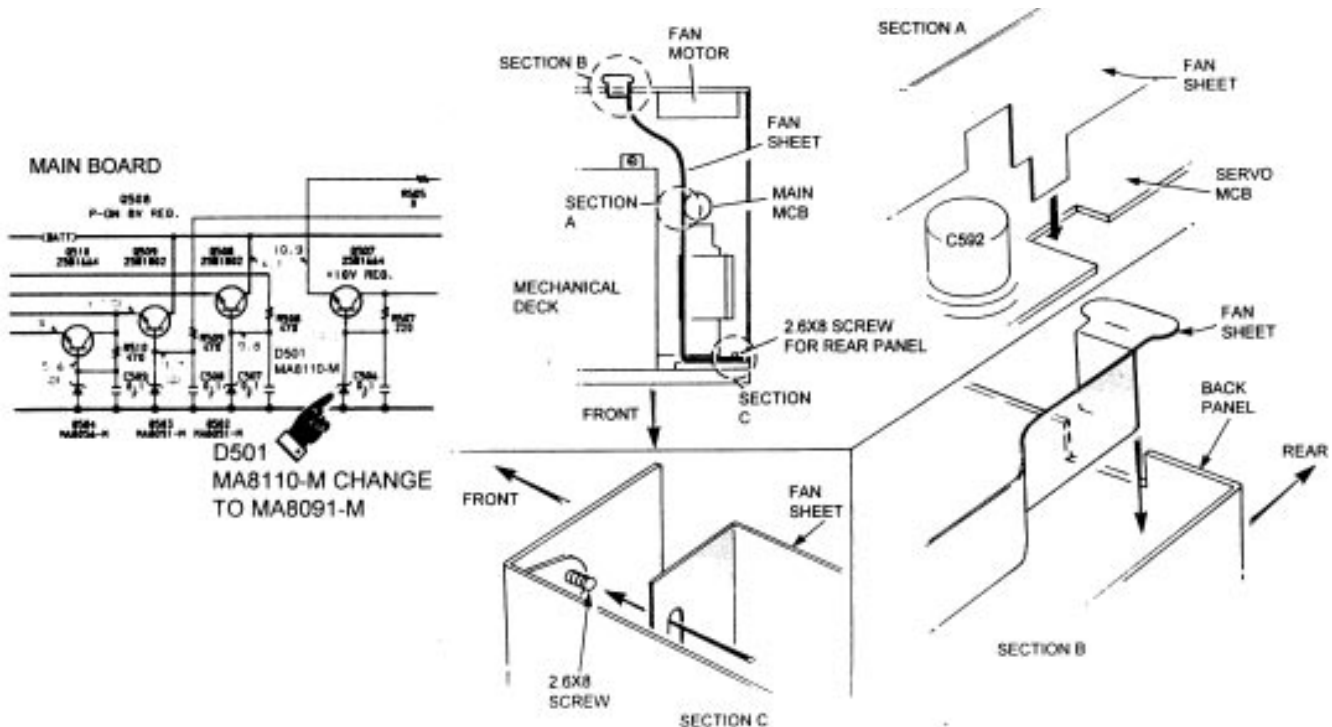
The unit may skip, or audio drop-outs may be heard. This problem may be caused by dust on the objective lens. The dust may be the result of the fan producing excessive air circulation.

If skipping and/or drop-outs occur, and dust is found on the lens, change D501 on the Main board to a different type, and add a fan sheet as shown below.
