Car Stereo Service Bulletin

CSA-14

Model: EXR-21, XR-6450, XR-C190, XR-C210, XR-C410 **No. 396**

Subject: No Tape Play In Reverse. **Date:** April 4, 1996

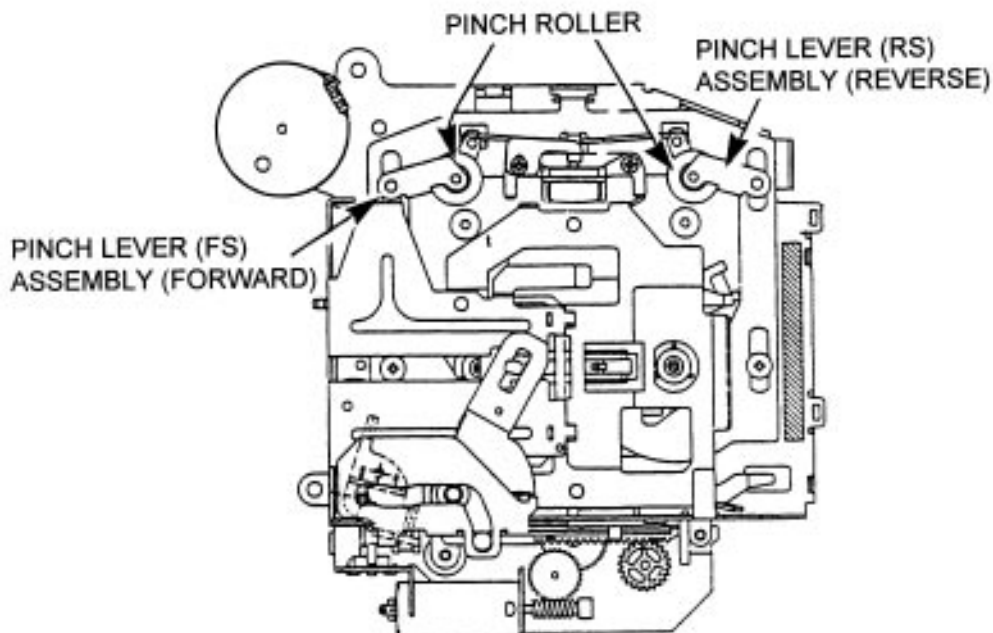
Shortly after reversing the tape, the mechanism returns to forward play. This problem may be caused by both pinch lever assemblies simultaneously engaging the tape and both capstans.

Solution: Replace the forward and reverse pinch lever assemblies as shown below:
