Service Bulletin Car Stereo

Model: CDX-91

No. 400

Subject: Pop Noise Prior To Start Of Audio.

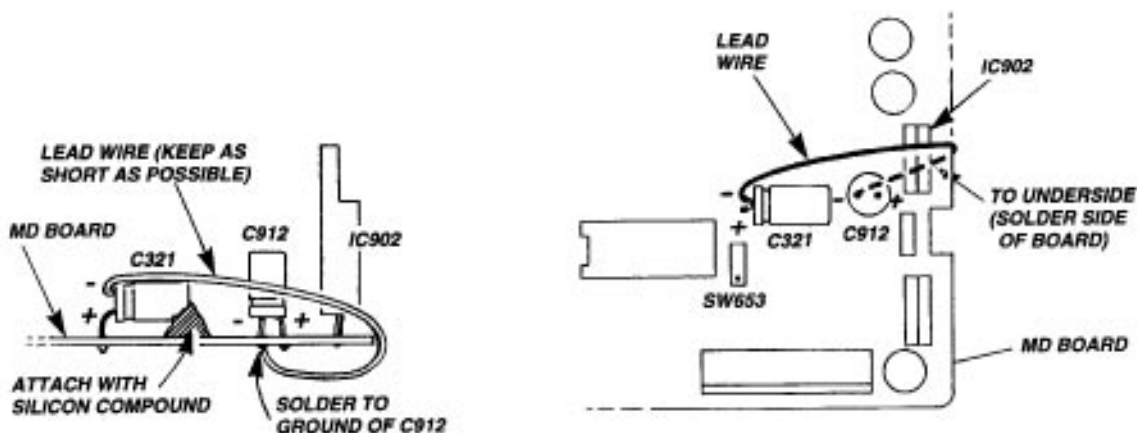
In some units after changing the disc, pop noise from the speakers may be heard prior to the start of audio.

Remove capacitor C321 from the MD board. Using the same type of capacitor solder the positive lead(+) of the capacitor to it's original positive (+) location. Bend the capacitor as shown in the diagram and mount it to the board using silicone compound. Next, take the ground(-) lead of the capacitor, attach a wire, and route it to the underside (solderside) of the board. Connect this lead wire to the minus side (-) of C912. Keep the wire length short as possible.
