Service Bulletin Car Stereo

Model: EXR-11, XR-1400

No. 401

Subject: SOUND LEVEL IS LOW IN ONE CHANNEL

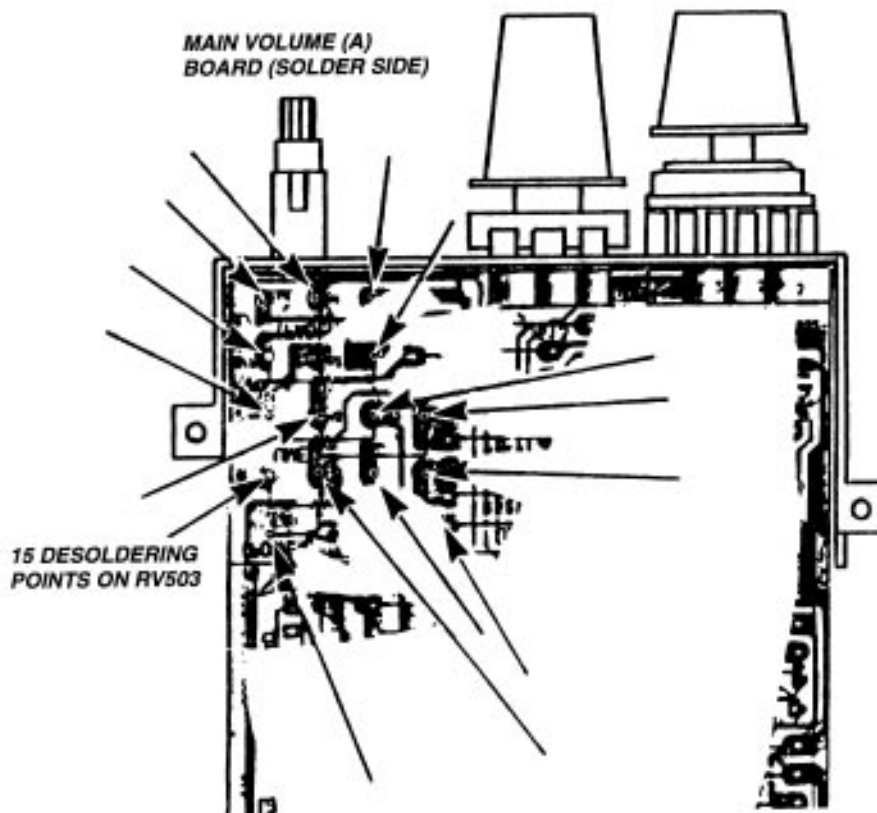
The sound level is low in either the Left or Right channel. The symptom may occur in some models due to a defective variable resistor.

If this problem is found to be caused by a defective RV503, remove it and replace it with a new one.
