**Model: XM-3046**

**No. 405R1**

**Subject: SOUND DISTORTION**

**Date:** October 10, 1996

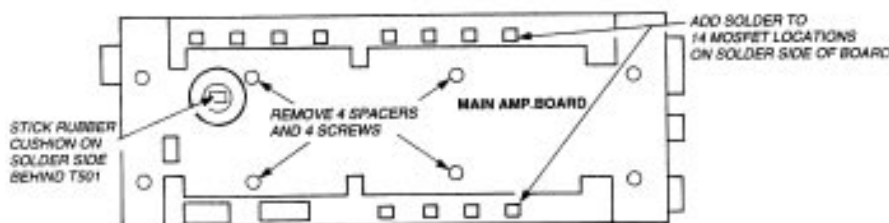
The audio outputs of the XM-3046 may be distorted. This may be caused when the solder breaks from off the MOSFET/PCB connection. The MOSFETS are located on the main PCB.

Remove the main AMP BOARD. Remove the four white plastic spacers ( near the center of board) as shown in diagram. Leave the remaining four spacers (near the edges) on the board.

Add solder to the lead of each MOSFET on the solderside of main PCB.

MOSFET REF# ( Q109,Q110,Q209,Q210,Q309,Q310,Q409,Q410, Q519,Q520,Q513,Q514,D511,D512 ).

Stick a rubber cushion on the solderside of the T501(Transformer). The part number of the cushion is listed below

Reassemble the main AMP Board. Do not replace the four spacers and screws which were removed.
