Service Bulletin Car Stereo

Model: XR-130, XR-150

No. 406

Subject: PREVENTING THE NOSE SWITCH FROM

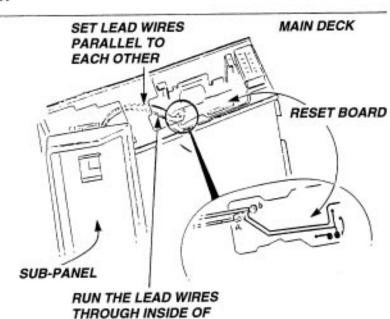
Fig.3

THROUGH INSIDE OF THE CHASSIS SOLDER TO RESET BOARD

- 1- Remove the sub panel
- 2- Remove SW303 (Nose Detect Switch) on reset board.
- 3- Prepare 2 Lead wires (90mm long).
- 4- Solder the 2 Lead wires to the new switch as shown. (fig.1)
- 5- Mount the switch onto the lock assembly using the P2 x 5 screw as shown. (fig.2)
- 6. Solder the Lead wires of the switch to the holes of the reset board, where switch was originally soldered. Polarity of wires is not important. (fig.3)
- 7. Replace the back of the front panel with the new one indicated in the parts table above.
