Model: EXR-400, EXR-500, XK-R100, XK-6700, XR-C190, XR-C223, XR-C300, XR-C400, XR-C410, XR-C520, XR-C610, XR-C620, XR-C720

No. 410

Subject: THE TEETH OF THE LOADING GEAR MAY BECOME BROKEN. THIS MAY HAPPEN IN MG-50 SERIES MECHANICAL DECKS.

Date: October 22, 1996

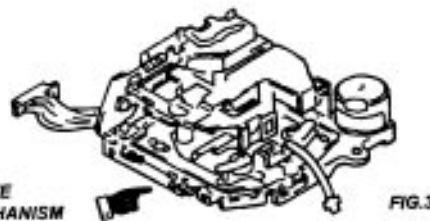
mechanism decks produced from Jan 1, 1995 to June 30, 1995 are applicable. The production date can be identified as shown in the illustration below

EXAMPLE: 45707_/_/_/_/C indicates mechanism was made on JULY 7, 1995. These numbers are printed on the mechanism. The applicable products will range from 450101_/_/_/_/C to 450630_/_/_/_/C
