Service Bulletin Car Stereo

Model: XR-C900 No. 414

Subject: NO POWER ON OR NO SOUND WHEN UNIT Date: January 6, 1997

HEATS UP

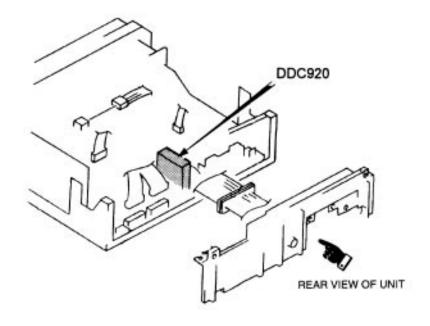
(11) The unit will have no power or no sound when a certain high temperature is reached.

This may be a protection circuit malfunction of the D/D converter (REF# DDC920).

Solution: Replace the DDC920 on the main board with an improved DC to DC converter
