Model: CDX-3100, CDX-3160, CDX-4160, CDX-5100,
CDX-C410, CDX-C510, CDX-C610, CDX-C710,
CDX-C810DSP, EXCD-21, EXCD-31, EXCD-206,
EXCD-306, EXCD-406, EXR-C205, XR-C350, XR-
C400, XR-C450, XR-C500, XR-C700, XR-1750,
XR-3753

No. 427

Subject: DISTORTED OR NO AUDIO IN ONE OR BOTH
CHANNELS

Date: May 6, 1997

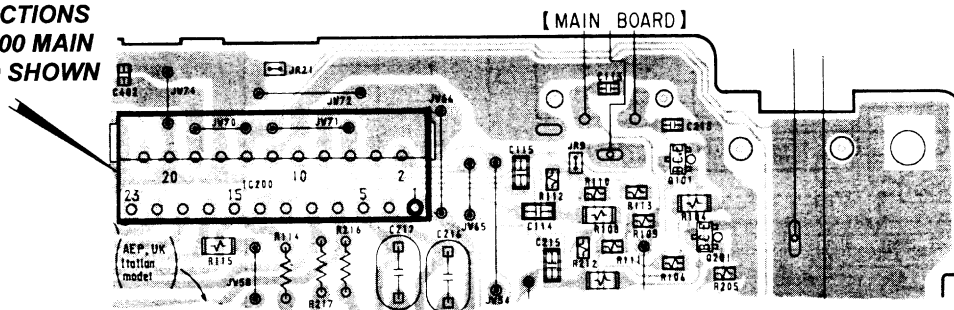
Some of units may have problems with the audio output. This may be due to insufficient solder connections from the power amplifier IC (HA13155) to the MCB. If you are experiencing these symptoms you should inspect the power amplifier inside the unit. There may be poor solder connections. Ring cracks may be visible around several pins.

**CHECK IC200
SOLDER
CONNECTIONS
CDX-3100 MAIN
BOARD SHOWN**

Solution: Resolder and carefully inspect Power Amp IC. Make sure solder connections are good.
