Car Stereo Service Bulletin

Model: XR-7280/7190

No. 205

Subject: High Wow and Flutter

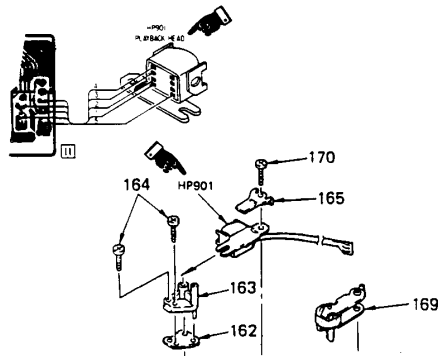
When using old or poor quality tapes, wow and flutter may be high. The friction coefficient between head and tape is too high. This causes the tape to stick to the head resulting in high wow and flutter.

Replace the head with the improved type listed below. The improved head has a grooved surface which reduces friction:

FORMER		NEW TYPE	
Description	Part No.	Description	Part No.
Sankyou Permalloy Head	1-543-506-11	Cannon Permalloy Head	1-543-726-11
